HEAVY RAINS RESULT IN SERIOUS DAMAGE TO THE “MAHAUT” ROAD

Submitted by Cecil Henry, Ministry of Agriculture, St. Lucia.

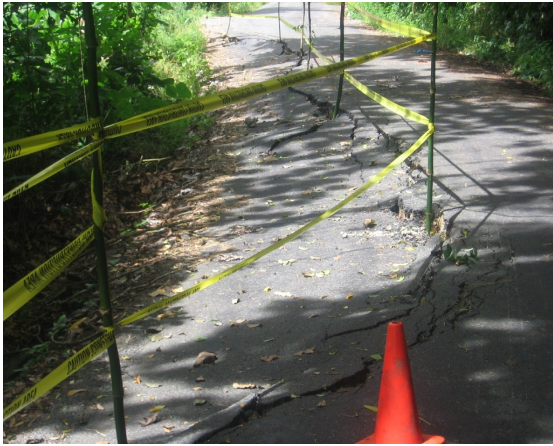
A-1

The above pictures depict the level of damage on a major section of road in the Mahaut area. This event occurred around mid October-November 2005 and since then damage has hindered the free flow of motorists (farmers and tourists). The damage stretches for approximately 300 feet and is displayed in two (2) phases, 1 and 2 with the second occurring within 2-3 weeks of the previous. The heavy rainfall period has since ended, however, based on observations is quite possible that damage will worsen due to the movement of traffic, and more particularly heavy duty dump trucks which make their daily trips to the pumice mining area which is approx. 1/4 mile beyond the damaged area. No immediate plans have been drawn up to address this situation, notwithstanding that an international based contractor had just resurfaced the entire road from the highway.

Some of the measures which could be employed to arrest this current situation could include:

- Establishment of appropriate forest trees species on the site of the displaced soil.
- Improved roadside drainage.
- Installation of subsurface drainage system for the area.
- Upgrading the quality material for road construction/resurfacing.
